Analysis of Pedestrian Safety on Five Major Arterial Roads in Dhaka, Bangladesh

Upal Barua and Dr Richard Tay
University of Calgary

Dr. Md Mazharul Hoque and Md. Sha Al Mamun
Bangladesh University of Engineering and Technology

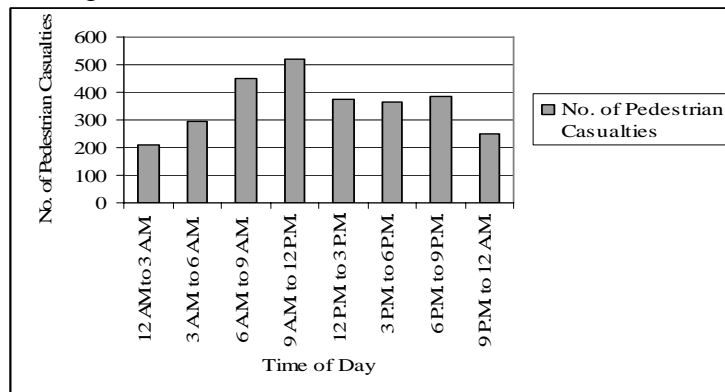
The above inference is also supported by the fact that most of the pedestrian casualties occurred between 6.00am and 9.00 pm (see Figure 2), with the peak occurring between around 9am. These times coincide with the peak travel times, especially the morning peak for commuting.

Figure 2: Time Variation of Pedestrian Casualties

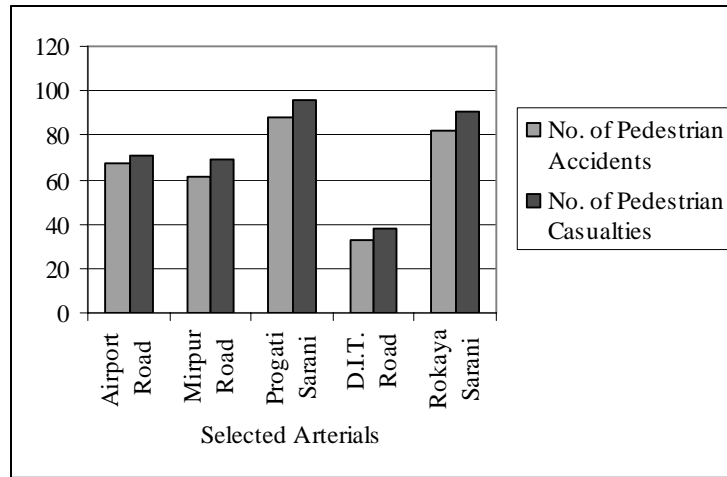
The spatial distribution of pedestrian collisions and casualties in the five major arterial roads is shown in Figure 3. About 17.3% of the total pedestrian crashes in Dhaka City occurred on these selected arterials. The highest number, 88 crashes (4.6%) occurred on Progati Sarani, followed by Rokaya Sarani which accounted for 4.3% or 82 crashes.

Figure 3: Crashes and Casualties on the Selected Arterials

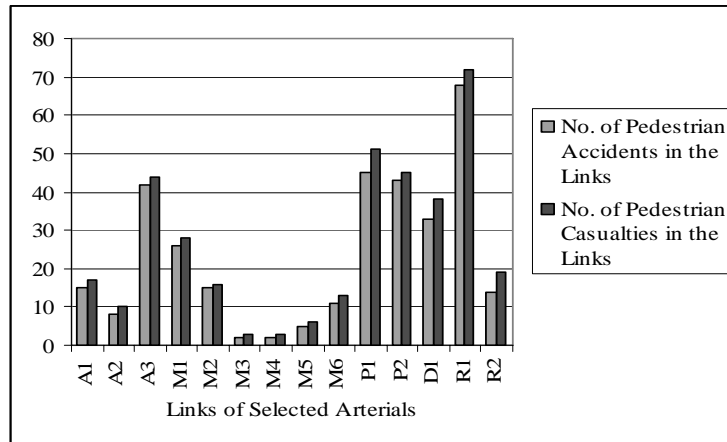
Figure 4: Collisions and Casualties on Selected Links

If separate links are considered, the R1 link of Rokaya Sarani (Senpara, 50 meter south of Mirpur-10 to Kafrul)

accounts for the highest number of pedestrian collisions (67) and casualties (72) among the selected links, followed by the links on Progati Sarani, with over 40 crashes each (see Figure 4). Another link with over 40 crashes is link A3 on Airport Road.

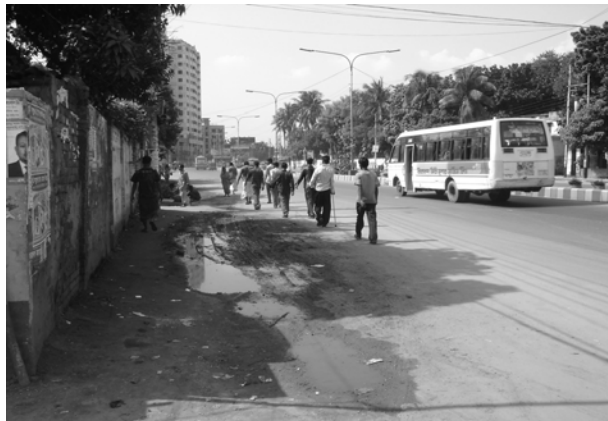
One of the problems for pedestrian safety in Dhaka City in general and along the five arterials in particular is the lack of adequate provision of proper footpaths and pedestrian walkways in many locations. The lack of an adequate side walks often forces pedestrians to walk along the arterial roads themselves making the pedestrians vulnerable to vehicular traffic (see Figure 5).

Figure 5: Lack of Adequate Pedestrian Sidewalks

the designated crossing facilities (see Figure 8). Although low fencing are installed in some places, they are insufficient to deter pedestrians (see Figure 5). Moreover, the existing black fence barriers are sometimes not very visible at night time.

1. Provision of user friendly footpath: Safe and user friendly footpaths must be provided. It is also important to ensure that encroachment by hawkers is properly managed.

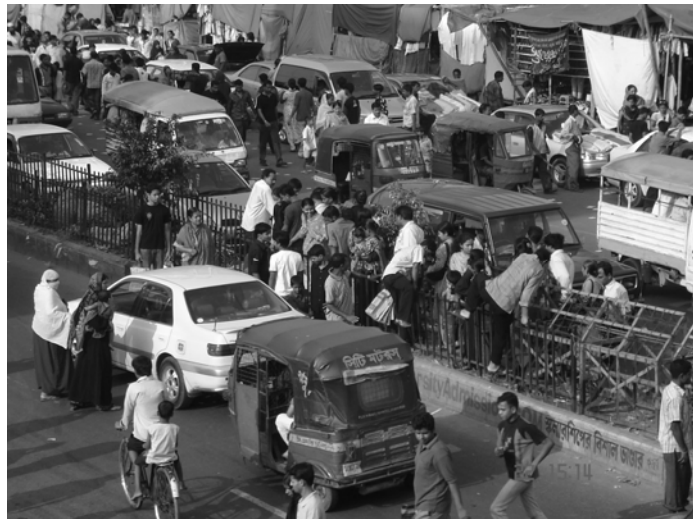
Another serious safety problem is encroachment of hawkers on the footpaths in the commercial areas. Vendors spread their wares on the footpath and eventually reduce the effective width of footpath. In many links, especially at M6 link, almost all the footpath width is encroached by them. Hence, pedestrians are forced to walk along the road rather than the footpath creating serious safety hazard (see top of Figure 6).

Figure 6: Hazardous Pedestrian Crossing

Besides encroaching on the footpaths and side walks, having vendors along the roads also increases pedestrian traffic. Moreover, vendors and shoppers are often distracted and not fully aware of the vehicular traffic. In addition, they also pose as distraction for some drivers. Finally, these road side markets also encourage pedestrians to cross illegally and dangerously to get to the vendors (see Figure 6).

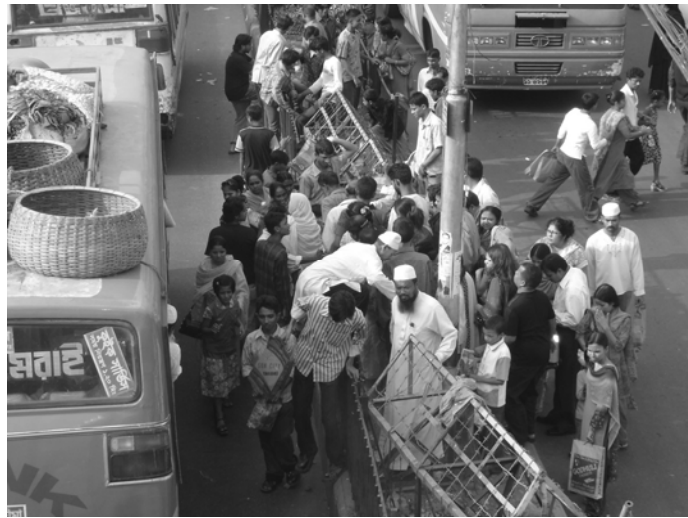
There are very few designated places for buses to stop along these major arterials. Most of the buses stop at the road side haphazardly and causes a serious safety problem for both vehicular and pedestrian traffic. This unregulated stoppage also induces passengers to alight and board the bus under dangerously traffic conditions. Moreover, such

behavior often results in road sides and side walks being crowded with passengers, thereby influencing pedestrians to move onto the road.

Figure 6: Bus Passengers and Pedestrian Behaviors

As shown in Figure 6, the buses often stop in the middle of the street near the flaring to serve as many passengers as possible. This unusual stopping and the sudden rush of passengers toward it may cause collisions associated with the passengers running for the bus and those getting down from bus in a hurry.

5. Provision of designated bus stops: Designated bus stops with properly designed bus bays and passenger waiting areas should be provided at appropriate places and behavior of passengers should be modified.

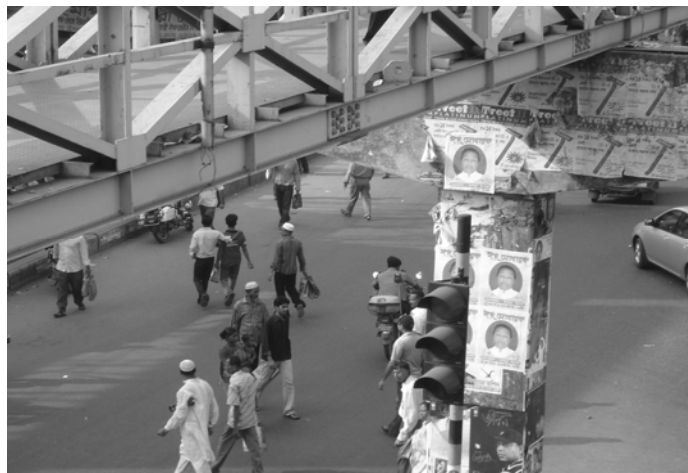
The underpasses and overpasses in these links are not heavily used because of a few real and perceived problems (see Figure 7). For example, accesses to overpasses along

Mirpur Road are often hindered by the encroachment of hawkers. Also, the aesthetic and perceived physical conditions of the overpasses are also not as good as can be at DIT Road and Pragati Sarani.

Figure 7: Under Utilization of Overpass

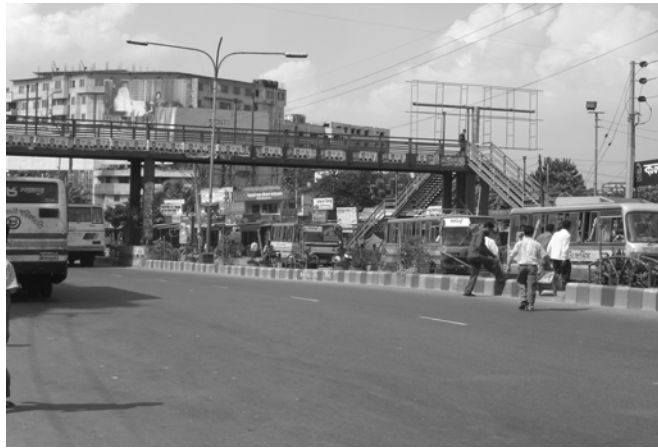
Due to absence of adequate median barriers allowed pedestrians to cross the road haphazardly instead of using

Figure 8: Inadequate Median Barriers

4. Installation of pedestrian refuges: In multilane streets, raise medians and other pedestrian refuges should be used. In addition, 'yield to pedestrians' signs should be installed at all approaches to designated crossings.

8. Separation of vehicular and pedestrian traffic: Space separation with self-enforced restrictive engineering measures New Jersey type concrete barriers should be given more consideration to improve pedestrian safety.
