SOME OBSERVATIONS ON ILLEGAL U-TURN ACTIVITY

Gordon G. Baldwin

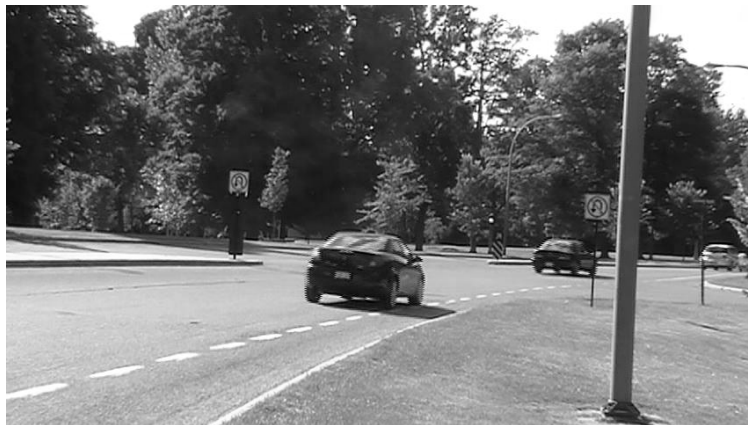
For the purposes of this study, one particular location was chosen where U-turns are prohibited and signed accordingly. While there could possibly be different opinions as to the visibility at a particular portion of roadway, the intersection in question is clearly marked with many signs to indicate that U-turns are prohibited (Figure 1).

Figure 1. Intersection of Island Park Drive and Island Park Crescent, Ottawa, ON

To a large extent, the findings were very positive from a roadway safety perspective. Of the 3,743 vehicles passing during the observation periods, only one performed an illegal U-turn on Island Park Drive (turning left across Island Park Drive to drive southbound). Given the volume of traffic, the speed of traffic and the visibility, this appeared to be the most dangerous point in this area for a U-turn and likely the reason that they were prohibited. Three separate signs warned that the activity was prohibited (Figure 1).

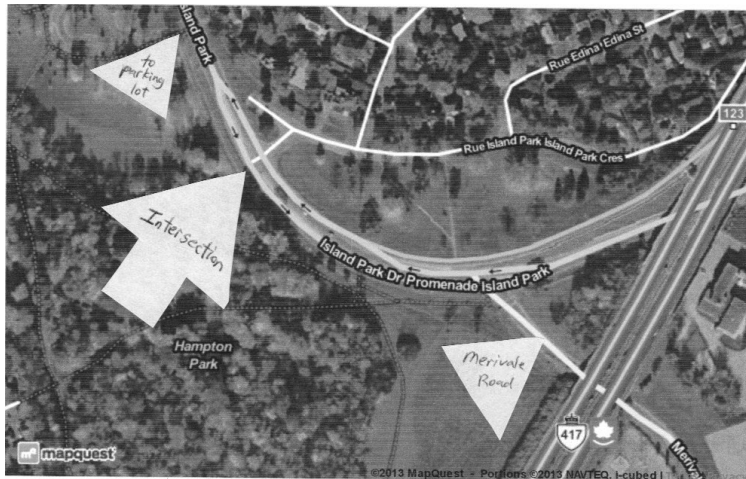
Source: Mapquest, downloaded January 14, 2013

The intersection observed in this study is Island Park Drive heading north and the intersection with Island Park Crescent (Figure 2). It is a major route to funnel traffic off the Trans-Canada Highway 417 to the province of Quebec via the Champlain Bridge. Traffic is typically heavier northbound in the evening (returning to Quebec) and southbound (heading to Ottawa) in the morning.

To try to solve the above three constraints, drivers northbound on Island Park Drive may be tempted to make a U-turn at the first break in the median separating northbound and southbound traffic. This break in the median occurs where Island Park Crescent meets Island Park Drive, and appears on a curve (likely the reason for the posting of signs indicating that U-turns are not allowed).

Figure 2. Road Layout in Study Area, Intersection of Island Park Drive and Island Park Crescent, Ottawa, ON

If one exits off Highway 417 at Island Park Drive, one can only head northbound, there is no southbound exit. This exit leaves one travelling northbound on Island Park Drive, there is no left hand turn on to Merivale Road from Island Park Drive northbound.

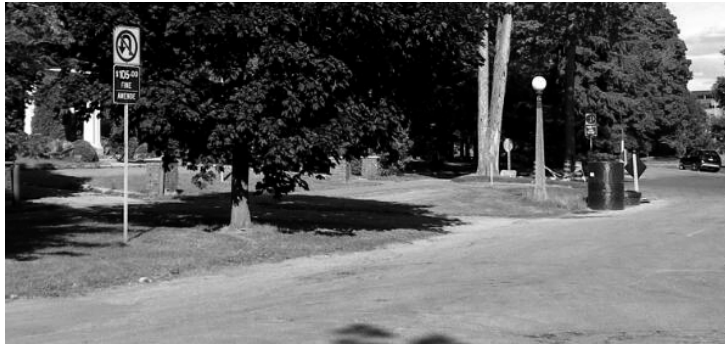
There was more observed illegal U-turn activity on Island Park Crescent where nine vehicles were observed making illegal turns. These vehicles turned off Island Park Drive and made a U-turn on Island Park Crescent despite three more signs showing that this was prohibited as well, see (Figure 3) then they turned left (southbound) on Island Park Drive. It is suspected that many more vehicles used this option as the volume of traffic on Island Park Crescent and the speed of the vehicles were both much less than on Island Park Drive.

Figure 3. “No U-turn” Signs on Island Park Crescent

This likely made the activity safer in the opinion of the drivers. It is possible that these no U-turns signs may have been posted after those on Island Park Drive, likely due to complaints by residents of the street unhappy with the U-turn activity on this quiet street.
